Process and Energy Optimization Assessment

Sierra Army Depot, CA

Process and Energy Optimization Assessment: Sierra Army Depot, CA

Final Report

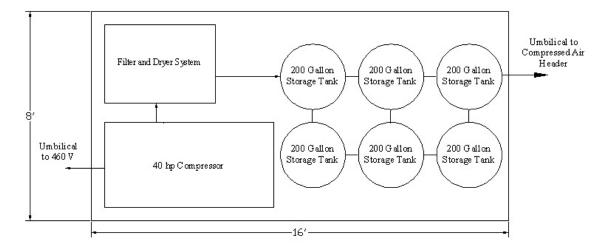
Figure 15. Breathing compressed air supply system.

Currently Building 672 has an inadequate supply of breathing air for its painting operations. Building 672 has two painting stations, but only breathing air capacity for one person at a time. There is adequate compressed air capacity in the process side, however, that system cannot be used for breathing air.

The proposed system is designed to supply approximately 140 CFM of Class D breathing compressed air at up to 80 psig. Class D quality meets OSHA regulations for breathing air. The skid mounted system is comprised of several components. The first component of this system is the 40 hp oil-free rotary air compressor. This compressor does not use oil to lubricate or cool the compressor, therefore, atomized oil cannot be entrained in the air stream, which minimizes the amount of contaminants that must be filtered out of the air. The next component is the dryer and filtration system. It is recommended that this be purchased as an all in one unit to comply with size and portability concerns. Such a unit contains a desiccant dryer to

There are several concerns that need to be addressed when installing this system onto a portable skid. Although the rotary screw compressor creates a low level of vibration, any vibration would disrupt operation of the desiccant dryer and could cause a potential safety hazard with the receiver tank. The compressor must be mounted with a vibration damper. One alternative is to mount the compressor on a separate skid from the dryer and receiver tank. Finally, to preserve the longevity of the air compressor, the skid should be parked only on a level surface during periods of operation.
